Missouri Bend Boat Slide Replacement Project

During July 2016, the Mid-Valley Chapter completed a full renovation of the Missouri Bend Boat Slide at the Bureau of Land Management National Park on the Alsea River. What most of you don't know is how this process occurred. The actual physical work took less than two weeks during this month, however, the process was well along by that time.

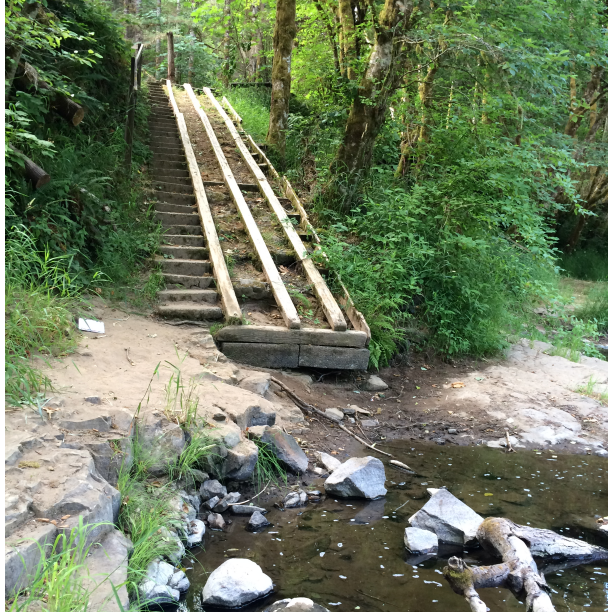
The concept for the project originated during 2014 when it was noted that the slide boards on the ramp and the guide boards were severely deteriorated. In addition, the cross-ties were creosote railroad ties and the slide boards were pressure treated lumber. We first had to learn about the Restoration and Enhancement Grant system in order to apply for funds to purchase replacement materials and support subcontractor labor. This was preceded by obtaining permission from the owners (BLM) with a letter of support for grant funding during September and October 2014. The grant process was completed and submitted early in November 2014. The grant required assembling a complete description of the site, identification of the flood plain, identification of the owners, complete description of the work intended, sketches of the proposed activity, and estimates of the materials and subcontractor support required. In April 2015, after grant application was submitted, our attendance to present the grant request to the R&E Review Board was necessary to answer any remaining questions or concerns raised by the R&E review group.

Bottom support was being eroded and boards were falling apart.
